STRUCK-BY LADDER FALL INCIDENT

Safety Topic V6-0775 Incidents, Ladders

DROPPED OBJECT STRIKES WORKER ON LADDER

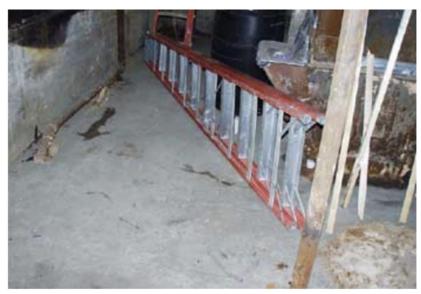
The pipe that fell was 5' 8" long, 3" in diameter, and weighed 12-15 lbs.

The 10-foot step ladder the worker was standing on.

- ➤ When overhead work is happening at the job site, workers below must be protected from falling objects, tools, and debris.
- ➤ Safety nets, canopies, and/or toeboards can be erected to prevent objects from falling from overhead operations to the ground level work site.
- ➤ When possible, workers should not be in the hazard area underneath overhead work.
- ➤ Workers should always wear hard hats when work is being performed overhead, or there is any risk of falling objects in the area.
